# Frp Bond Strength Degradation: An Experimental Study Using Pull-Off Testing

**FRP BOND STRENGTH DEGRADATION: AN EXPERIMENTAL STUDY USING PULL-OFF  
TESTING**

**THESIS**

MAJOR: CIVIL ENGINEERING

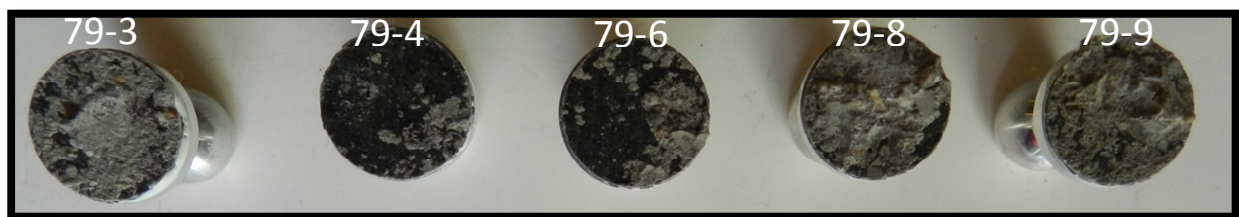
Figure 4.63: Dollies from testing the beam subjected to 40 cycles of 100°C and immersion in distilled water

After 40 cycles of 100°C and immersion in distilled water, failures were mixed, and average pull-off strength was 2.55 MPa. A high coefficient of variation was obtained, as shown in table 4.24. Figure 4.62 shows the beam tested after conditioning, while figure 4.63 shows the dolies failure faces.

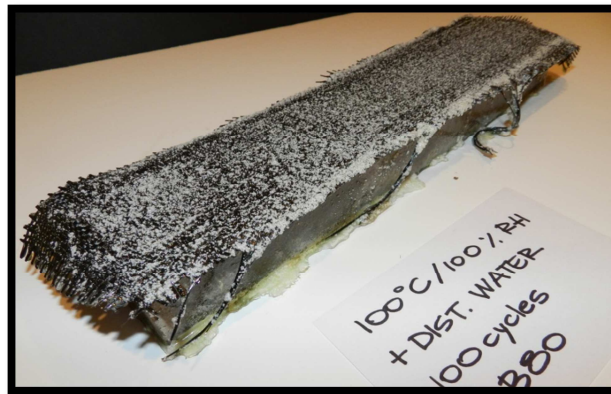
Figure 4.64: Beam exposed to 100 cycles of 100°C and immersion in distilled water.

The beam exposed to 100 cycles of 100°C and immersion in distilled water showed either mixed or adhesive failure modes. The average pull-off strength was 2.44 MPa, with a coefficient of variation larger than the 27.8% desired. Two out of the five pull-off values were lower than the minimum required by ACI 440, which shows the deterioration caused by the environmental conditions experienced. Table 4.25 shows these results.

Figures 4.64, 4.65, and 4.66 show respectively, the exposed beam, the tested dollies close to their testing locations, and the view of the faces of the dollies.

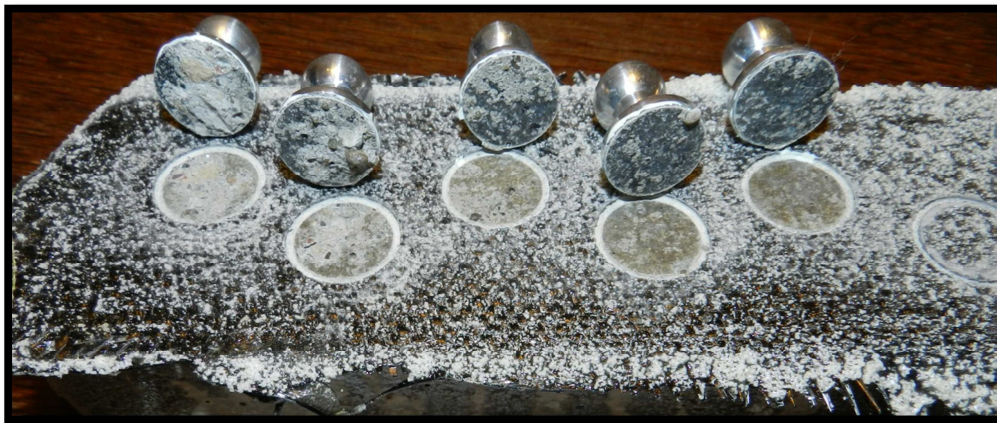
Figure 4.65: Beam exposed to 100 cycles of 100°C and immersion in distilled water with the tested dollies close to their testing locations.

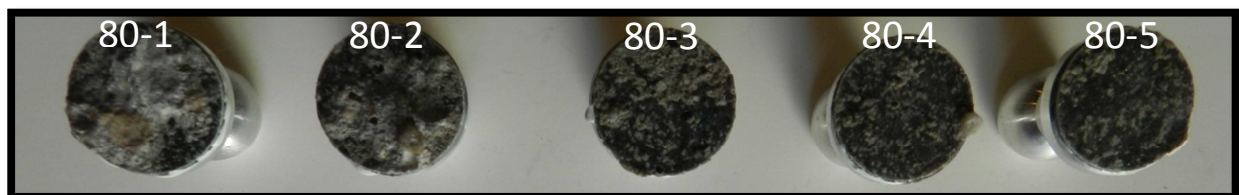
Figure 4.66: Face of dollies removed from beam exposed to 100 cycles of 100°C and immersion in distilled water

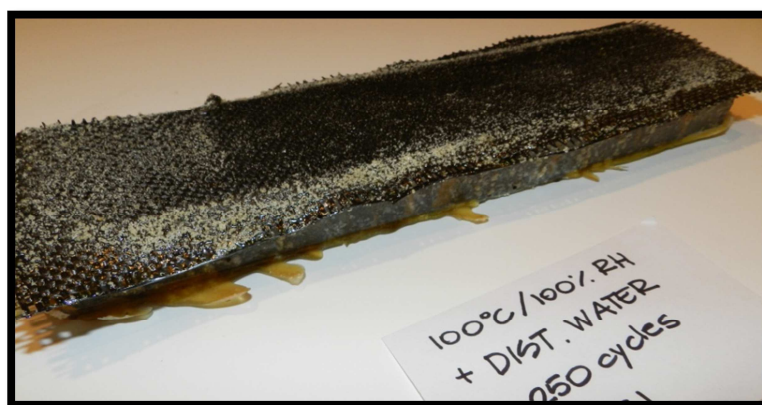
Figure 4.67: Beam exposed to 250 cycles of 100°C and immersion in distilled water.

Most failures in the beam exposed to 250 cycles of 100°C and immersion in distilled water were adhesive. The average pull-off strength was 2.06 MPa, with a coefficient of variation very larger. Table 4.26 shows the testing results for this condition.

Figure 4.67 shows the exposed beam, while figures 4.68 and 4.69 show the tested dollies close to their testing locations, and the view of the faces of the dollies.

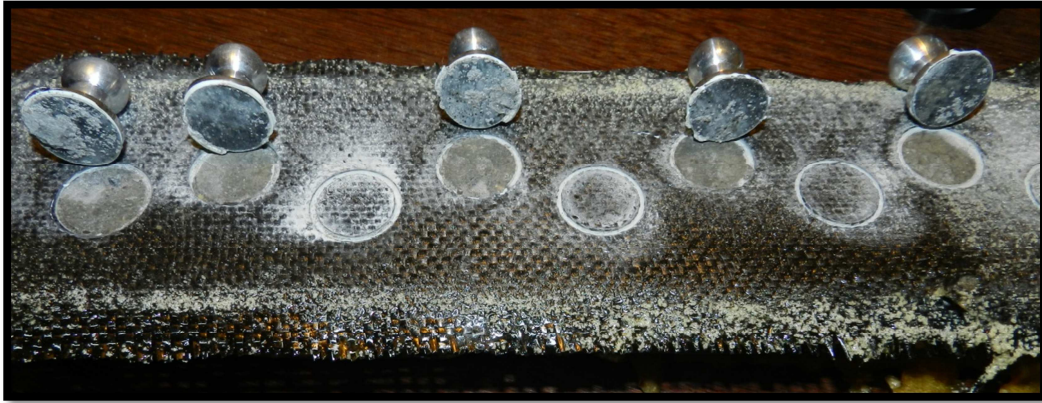
Figure 4.68: Dolliers from the beam exposed to 250 cycles of 100°C and immersion in distilled water.

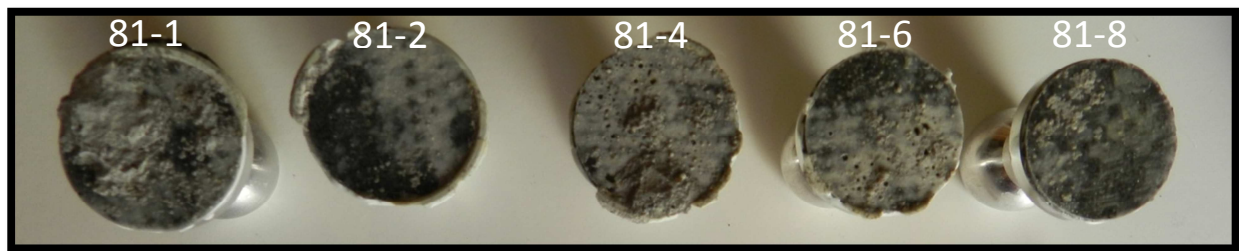
Figure 4.69: Faces of dolliers removed from beam exposed to 250 cycles of 100°C and immersion in distilled water.

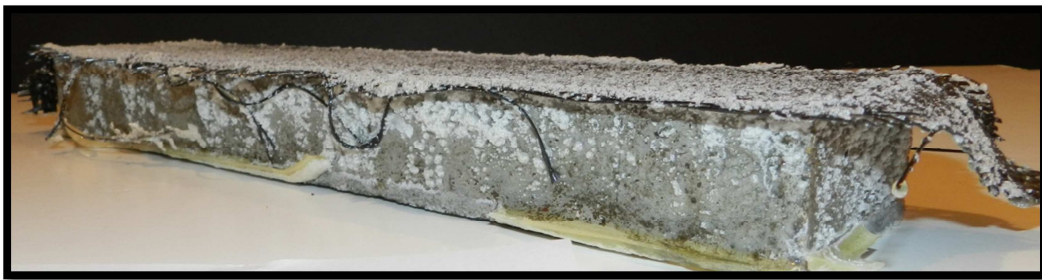
Figure 4.70: Beam after conditioning.

After 40 cycles under 100°C of temperature and immersed in salt water, all specimens showed a cohesive failure in concrete substrate, and the average pull-off strength was 5.31 MPa. Table 4.27 shows the test results. Figure 4.70 shows the beam after conditioning, and figure 4.71 shows the tested dolliers close to their testing locations.

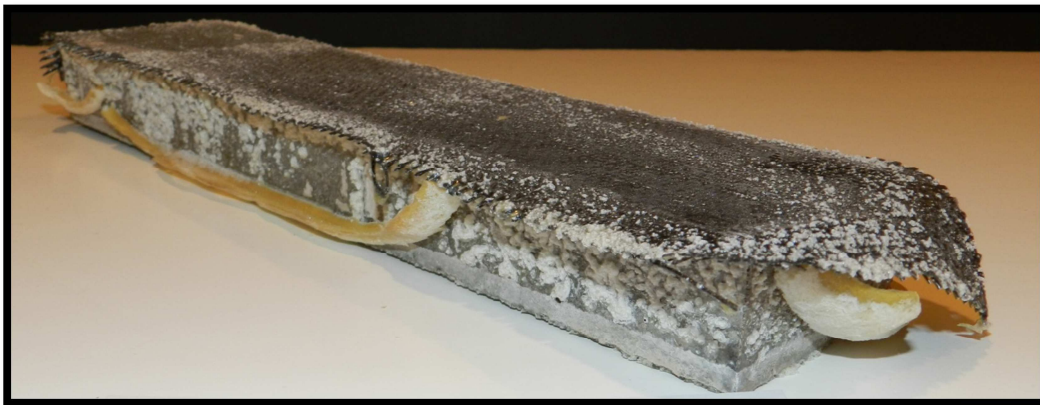
Figure 4.72: Beam after conditioning.

After 100 cycles of 100°C of temperature and immersion in salt water, the cohesive in concrete substrate was still the predominant mode of failure. The average pull-off strength was 4.51 MPa, as shown in table 4.28. Figure 4.72 shows the beam after conditioning, and figure 4.73 shows the dollies removed during testing.

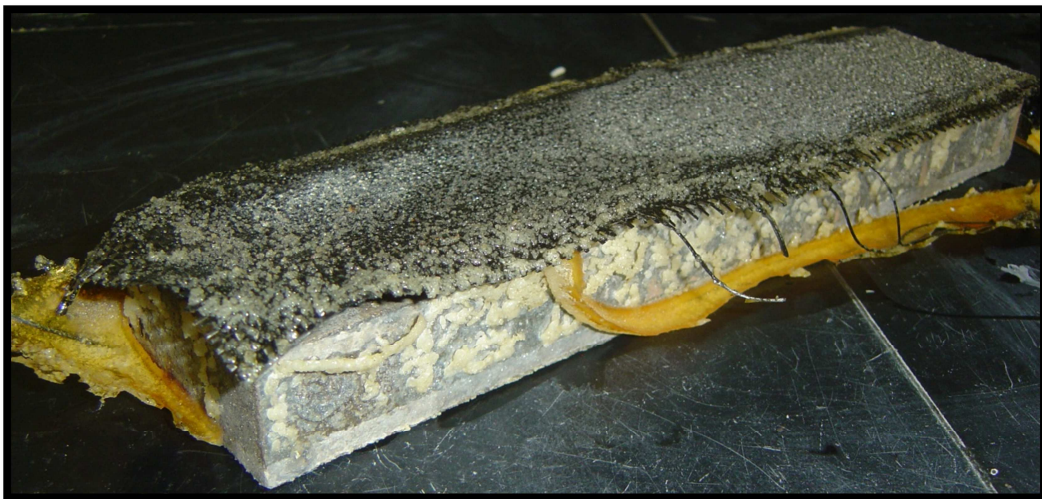
Figure 4.74: Beam after conditioning.

After 250 cycles of 100°C of temperature and immersion in salt water, only four specimens could be tested due to the delamination of the fiber on the remaining of the beam. Since the composite was visibly deteriorated, failures were predominantly adhesive, and the coefficient of variation was very high. The average pull-off strength was 2.10 MPa, but two out of the four values obtained were under the minimum required by ACI440. One of the pull-off tests had a high strength compared to the others adjacent to it, which confirms the limitation of the pull-off test for each localized test site.

Table 4.29 shows the testing results. Figure 4.74 shows the beam after conditioning, and figure 4.75 shows a closer view of the delamination. Figures 4.76 and 4.77 show the dollies removed during testing at each test site and the failure faces of each dolly.

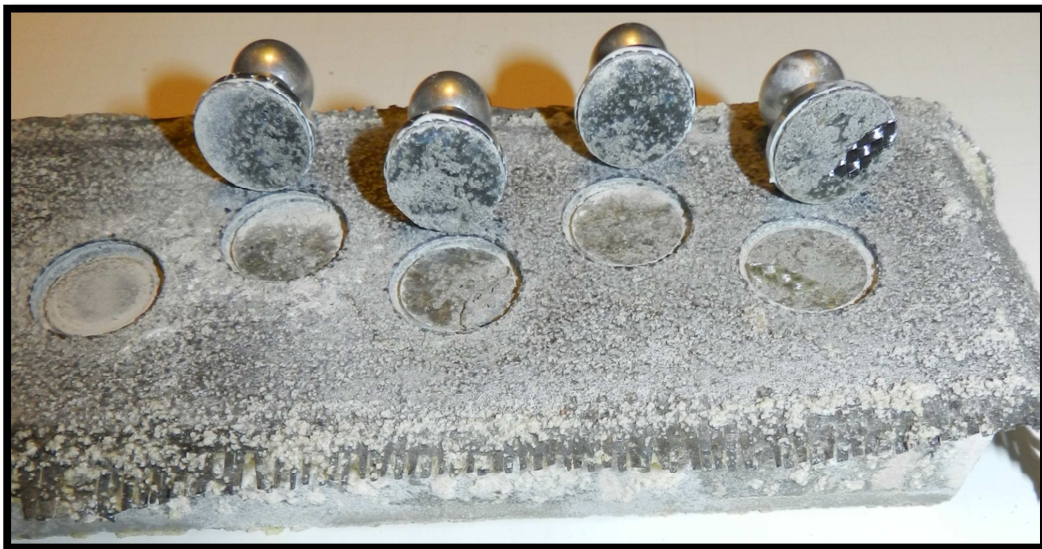
Figure 4.76: Dollies removed during testing at each test site
